Navajo Abandoned Uranium Mine Site Screen Report

Silver Bit No. 18 AUM Site

Navajo AUM Eastern Region

May 2009

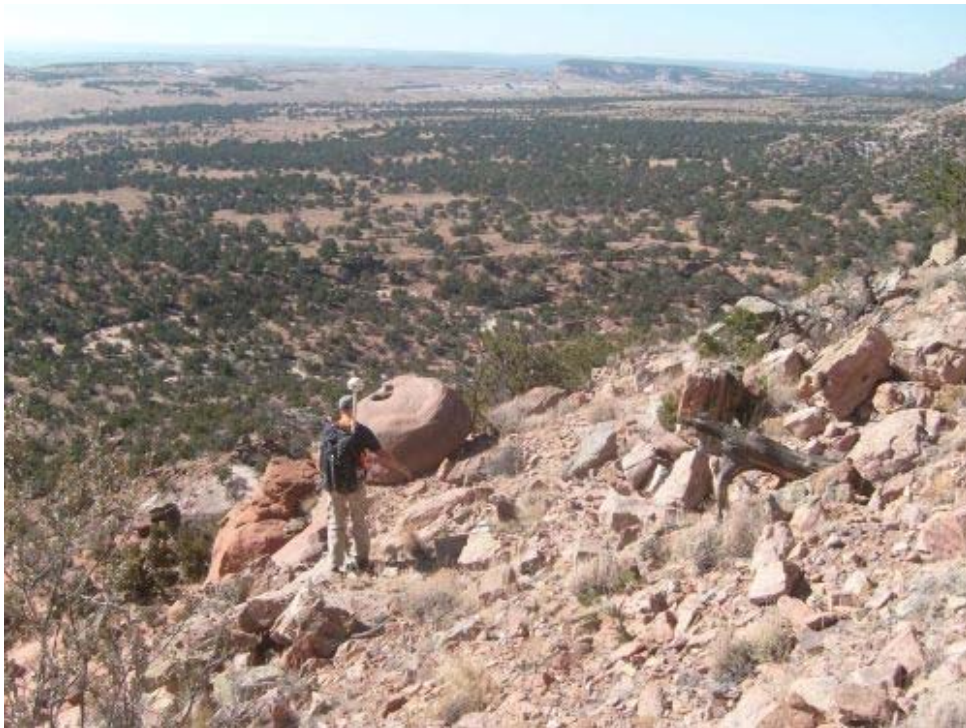
Photo 1. Silver Bit 18 mine site, towards the west on top of cliff

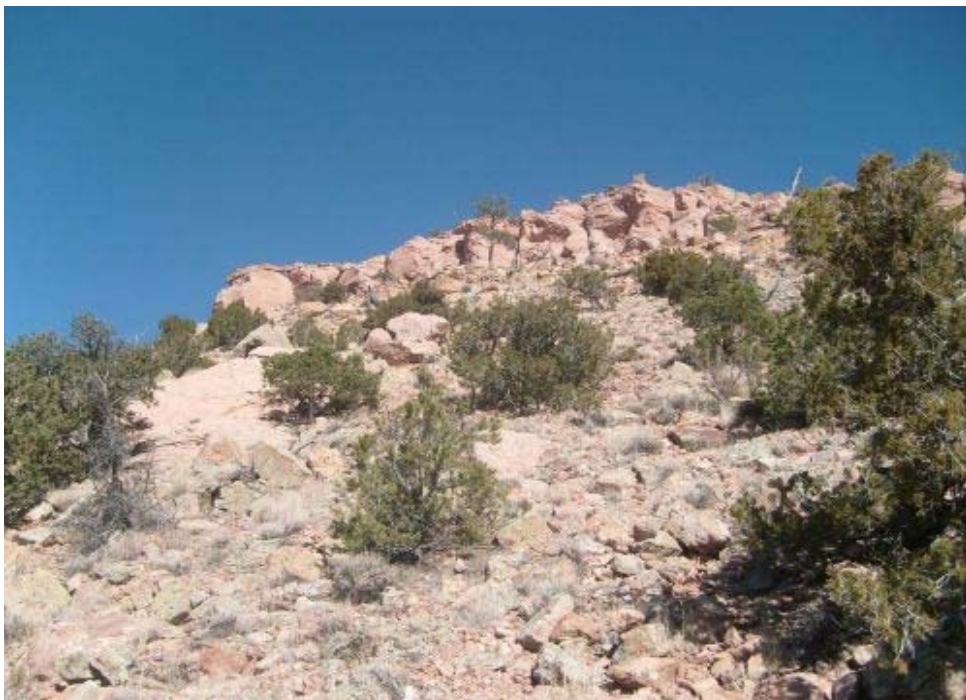
Photo 2. Silver Bit 18 mine site, looking up cliff to the north

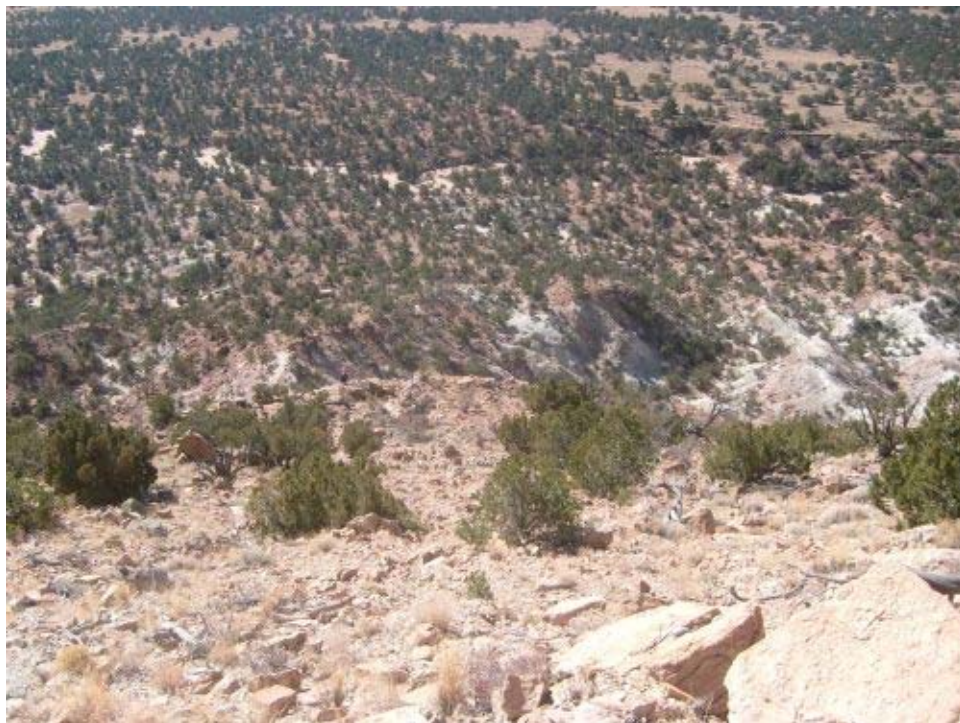
Photo 3. Silver Bit 18 mine site, looking down cliff face (top of site boundary)

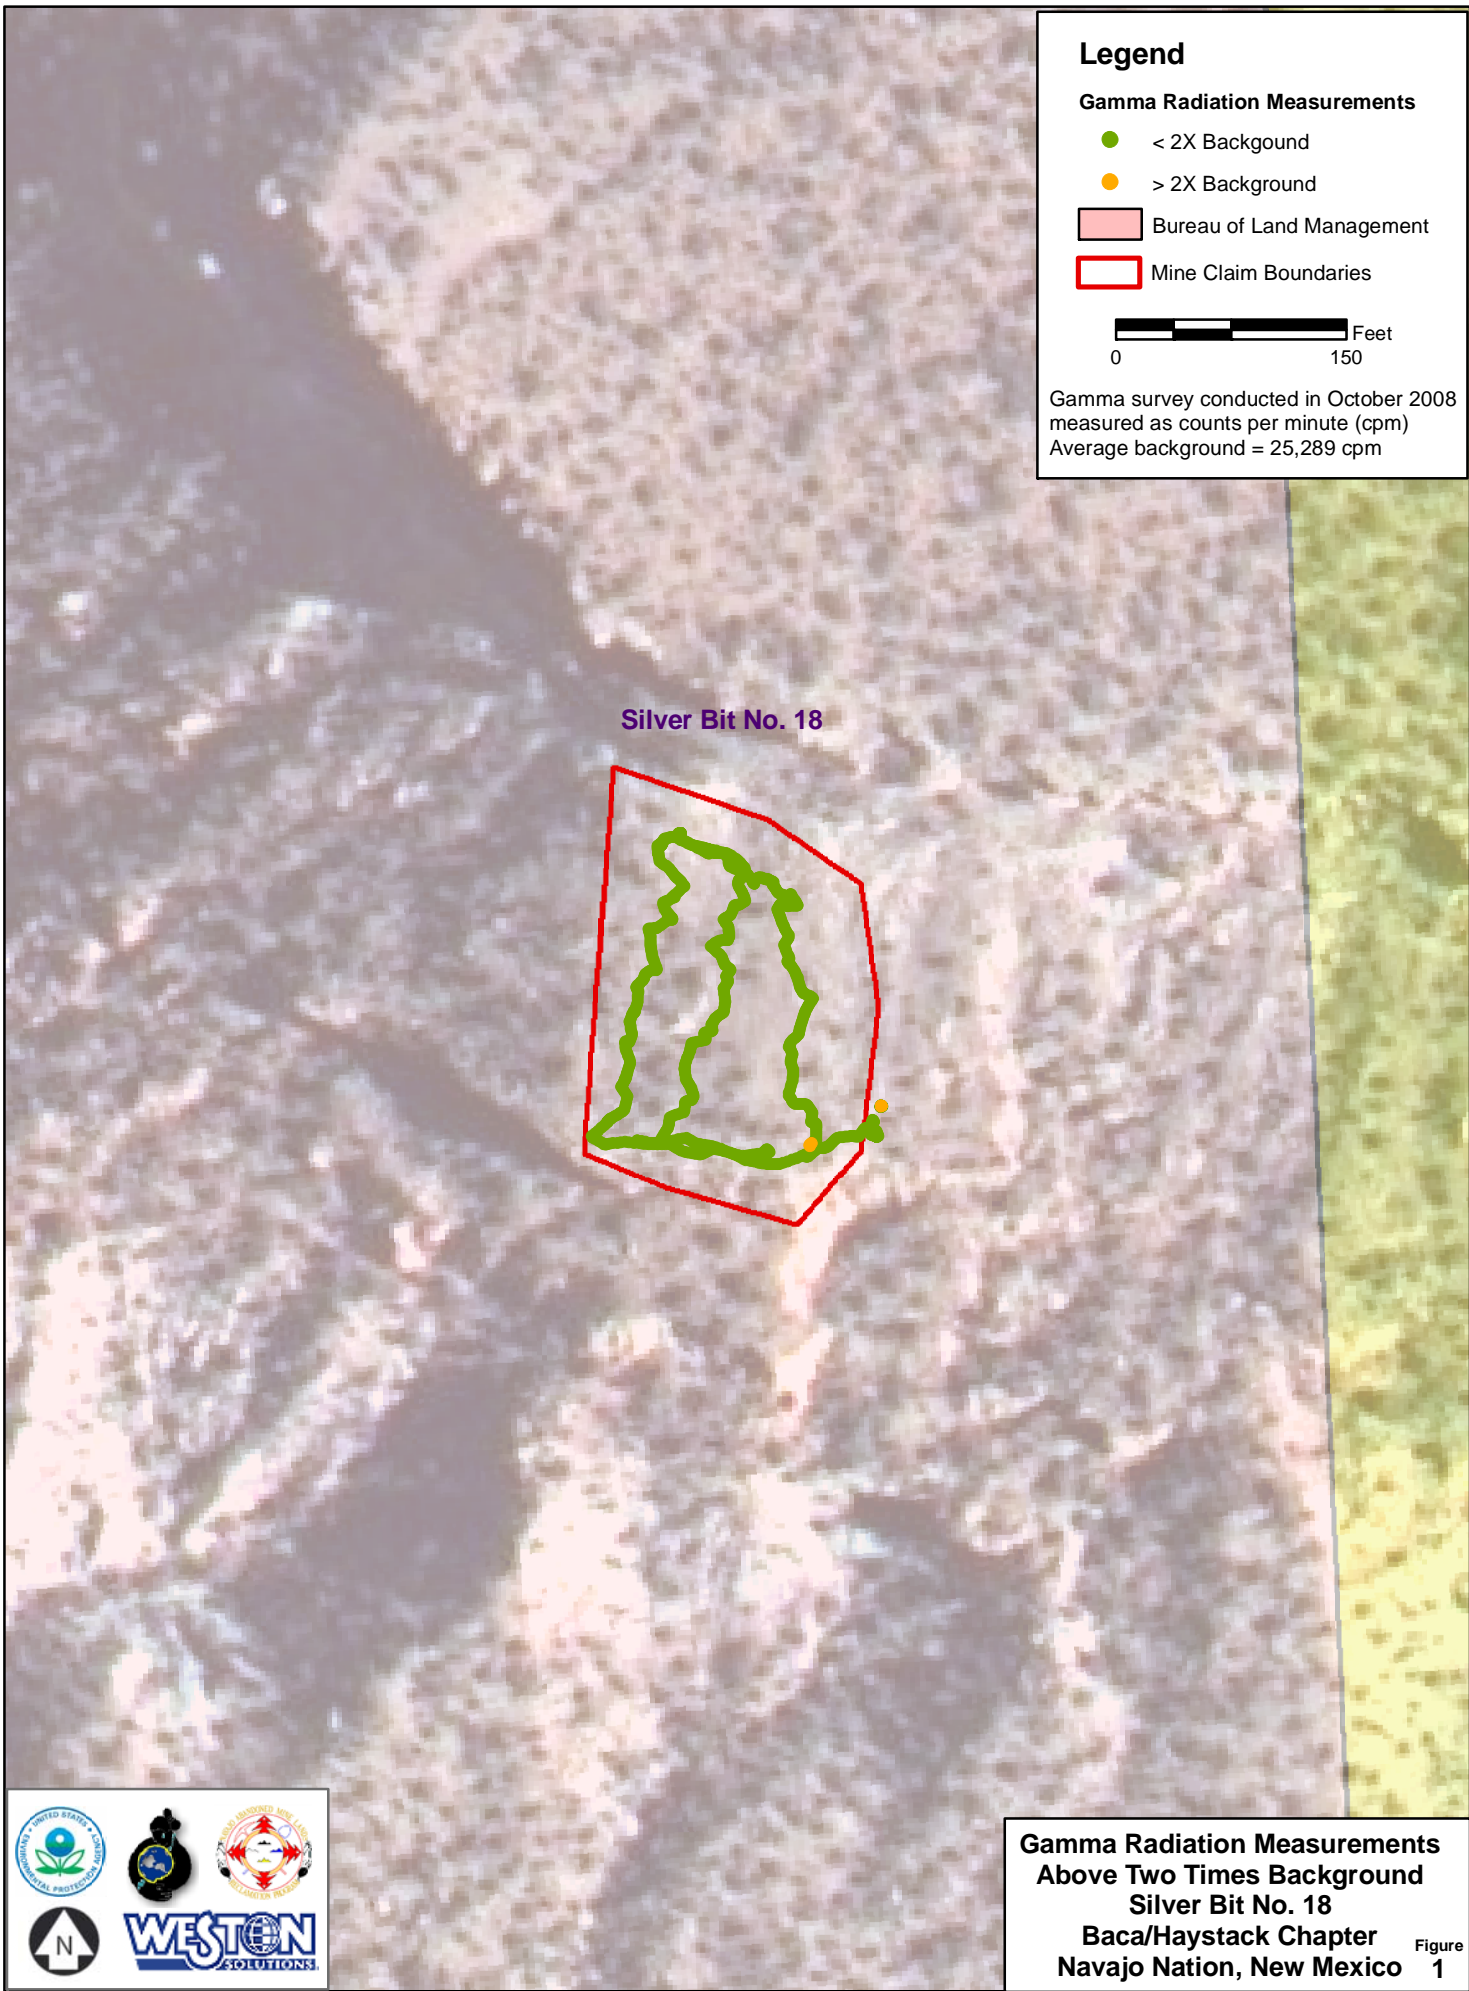
Figure 2

A total of 1,349 gamma radiation measurements were collected from the mine site, ranging from 10,636 cpm to 54,684 cpm. The measurements are represented in Figures 1 and 2. Radiological measurements collected for the New Mexico Mining and Minerals Division during a 2008 field screening survey found gamma radiation levels near the ground surface with a maximum of 160 micro Roentgen per hour ($\mu\text{R/hr}$) and a minimum of 24 $\mu\text{R/hr}$, levels at the 4-foot elevation with a maximum of 160 $\mu\text{R/hr}$ and a minimum of 21 $\mu\text{R/hr}$, and background levels of less than 20 $\mu\text{R/hr}$.

Gamma survey conducted in October 2008
measured as counts per minute
